BEHAVIOR OF SHORE PROTECTION STRUCTURES AT ALEXANDRIA, EGYPT, DURING THE STORM OF DECEMBER 2010

Abstract

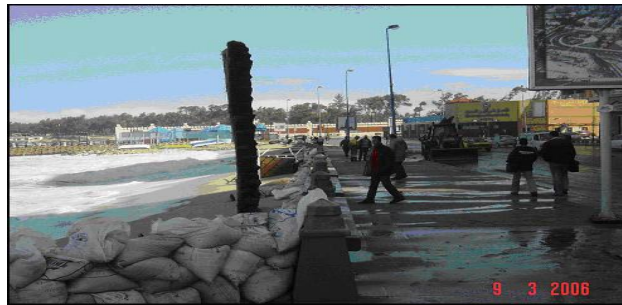
In the last few years, Alexandria coastline suffers from many erosion problems along its coastline which result from natural and human activities in the coastal zone. The beach width gradually decreased due to the action of the waves and currents. With the time, some beaches have disappeared totally and the wave action has attacked the toe of seawalls. Figure 2 shows example of erosion and flooding occurring at Alexandrian coastline during storm of winter 2006.

Figure 2. Erosion and flooding occurring at Alexandrian coastline.

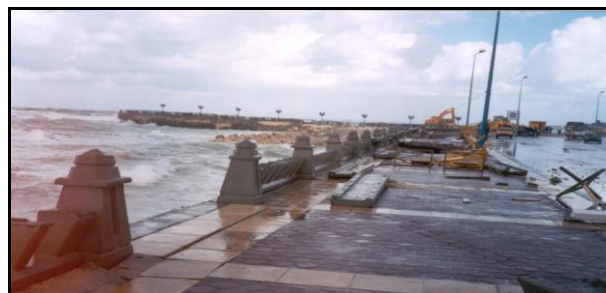
Flooding problems appeared also in these eroded areas affecting the traffic flow. In winter 2003 to 2006, the shore line of Mandara beach at Alexandria, Egypt, had suffered serious flooding and erosion problems. The sand beach was vanished with wave scouring underneath the road seawall. Waves and sea sand jumped over the broken seawall to the Cornish road as can be shown in Figure 3.

Figure 3. Example of flooding at the Alexandrian coastline.

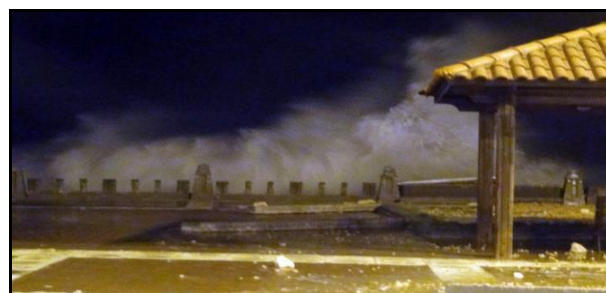
Recently, December 2010, a storm attacked Alexandria city and its beaches. The storm winds generated deep wave height of 7.5 meter for the first time in the last 100 years. As a result of this surge storms, water and sand overtopped the seawall and destroyed many parts of it. Figure 4 shows one example of this serious problem.

Figure 4. Wave attacks Alexandria coastline during the storm of winter 2010.

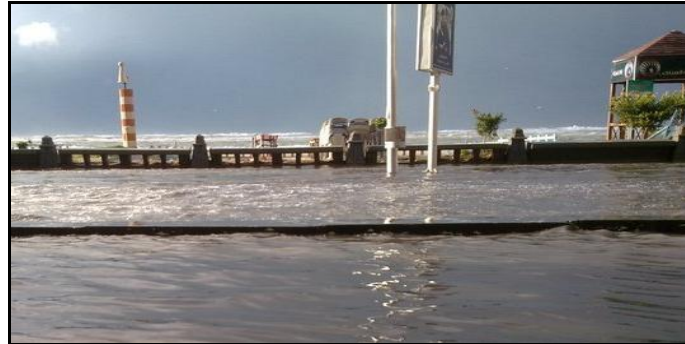
Due to the continuity of coming wave and speedy winds, the sea level has been raised for about one meter causing a serious flooding problem as shown in Figure 5.

Figure 5. Wave flooding due the sea level rise at Alexandria coastline, 2010.

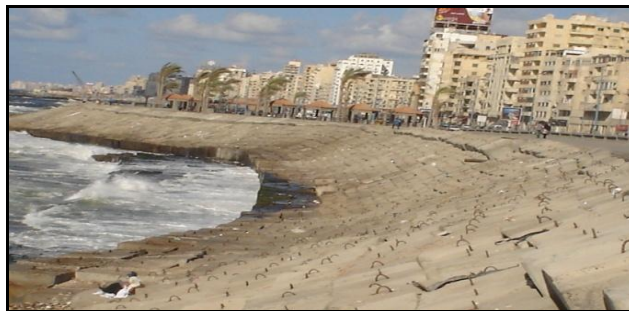
The second zone extended after Chatby to Cleopatra beaches for almost 3500 meters. This area has been strengthened by strong revetment. 20 to 30 meter width of 10 ton concrete cubic blocks have been installed for a height up to 5 meter as shown in Figure 7.

Figure 7: Shore protection by concrete cubic blocks at Sporting beach.

Along the shore line, between Chatby and Cleopatra (Zone 2), the several rows of concrete blocks were effective as a line of defense against wave attack. Only wave splash could pass over the revetment to the road. However, beach profile was completely reinforced and sand beach vanished without any comeback any time of the year. Due to wave flooding over the revetment several times during storms, many of the blocks, with steel hanging bars, cracked.

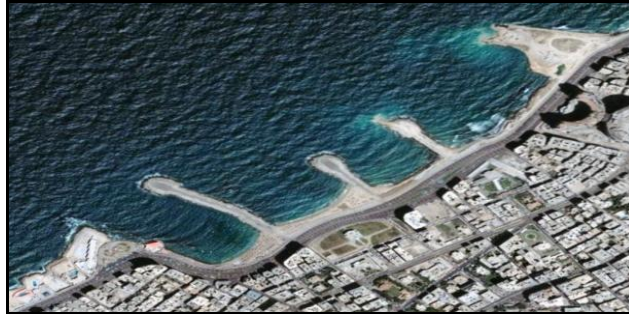
Groins have been selected for the protection of Gelem area as can be shown in Figure 8.

Figure 8: A satellite image for groins for Gelem Area, (Google Earth, 2009).

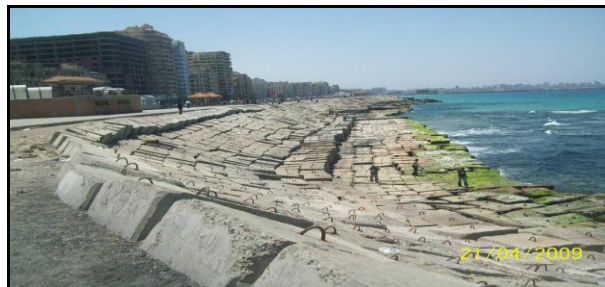
Next to San Stefano area, revetment has been adopted to Loran and Mahroosa areas. Figure 9 present this solution. As can see from Figures 7 and 9, the revetment protected the shore line against further erosion but the beach profile was completely reinforced.

Figure 9: Reinforcement of beach profile by concrete revetment at Loran.

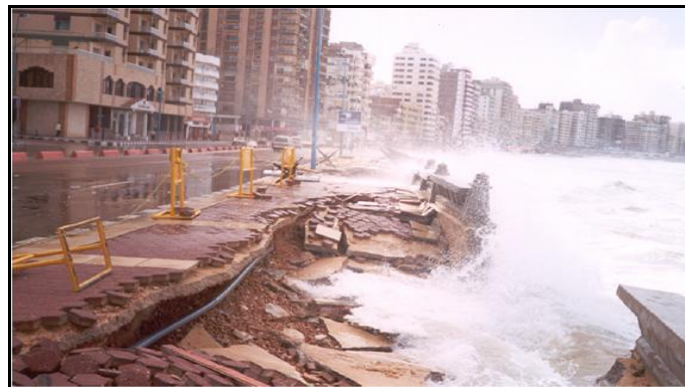
The zone is 3500 meters long from Miami to Montaza beach. This area has suffered severe erosion in 2003 storm. With time, the beach width decreased and vanished in some locations. The waves attacked the road itself after washing all the sand as can be notice from Figure 11.

Figure 11: Damage at Mandra beach during winter 2003.

In order to stabilize the eroded beach, a long, wide crest, and deep submerged breakwater has been constructed. The breakwater system consists of one main parallel breakwater and two overlapping parts as shown in Figure 12.

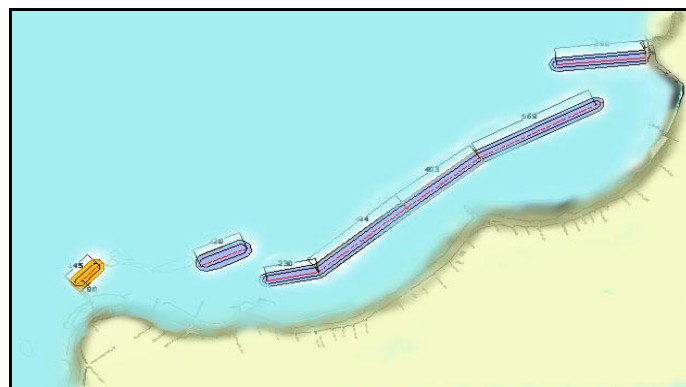
Figure 12: Layout of submerged breakwater applied at Miami-Montaza area.

Total length of the breakwater segments is almost 3000 meter, 150 to 350 meter offshore, and 2.5 to 8.5 meter depth. Width of the breakwater crest ranges from 36 to 46 meters which is equal to the incident wave length. The construction of the breakwater started 2006 and was completed in the beginning of 2009 except for a 100 meter long end part. The part across Beir Masood area has not been completed yet due to lack of finance.

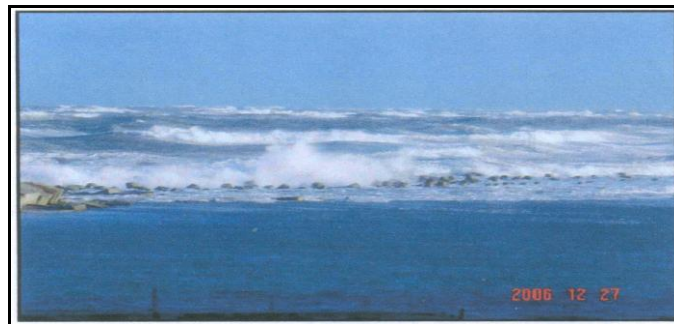
The submerged breakwater was attacked by 7.0 meter deep wave height in December 27th, 2006. Figure 13 shows the good efficiency of the breakwater in storm-condition. The shore line and sea-wall remained safe along the breakwater with noticeable good quality of water in the leese side in summer.

Figure 13: Efficiency of the submerged breakwater at 7.0 meter depth in storm time.

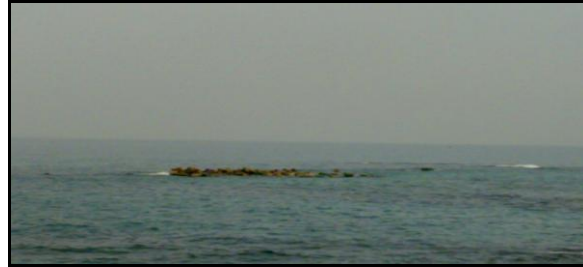
The narrow low crest detached breakwater used to protect Cleopatra beach (Zone 3) was a complete failure as presented in Figure 14. Most of the breakwater disappeared

and what left is good only for sea birds to rest on. Waves crossed the breakwater easily, and the relatively short distance between the breakwater and shore line did not do any good for energy absorption.

Figure 14: Failure of the detached breakwater at Cleopatra beach.

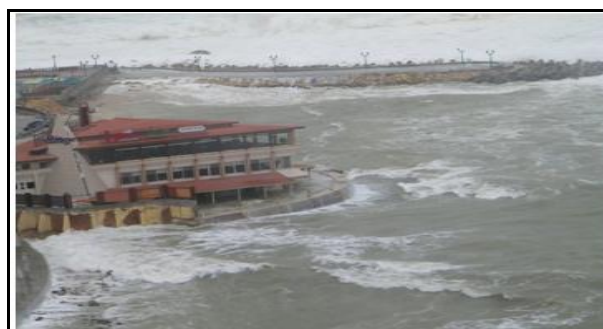
Gleem area (Zone 6) suffered severe wave attack during the storm. Groins added no good to protect beach and on shore buildings against wave action. Even, the very little accumulated sand within years has been disappeared during the storm. Figure 15 shows the low efficiency of the groins when waves attacked Gleem area during the storm of winter 2010.

Figure 15. Waves attacked Gleem area during the storm of winter 2010.

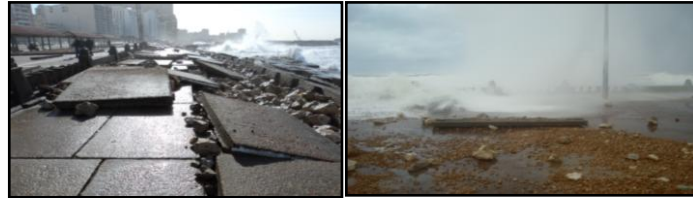
breakwaters. Loran and Mahroosa areas (Zone 8) nearby San Stefano experienced the worst storm effect in Alexandria. In spite of the concrete revetment, the concentration of wave energy caused a considerable destruction. Waves took off side walk concrete slabs out of the side walk after jumping over the revetment. Shore road was flooded with water and small aggregates and concrete fences were destroyed and through away. Figure 16 shows the damages of the concrete slabs and fences.

Figure 16: Damages of the side walk and concrete fences at Loran area.

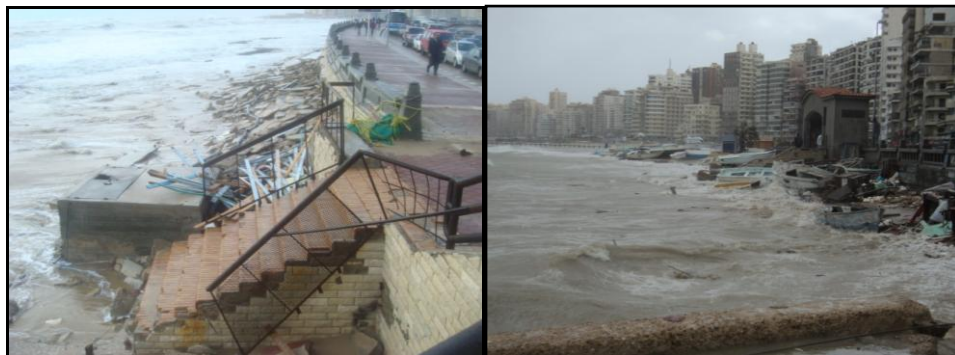
The natural submerged reef offshore at Sidi Beshher beach (Zone 9) could not help this time neither the sand nourishment. Waves covered the whole beach, attacked and destroyed fences and wood houses, and crossed over to the street as explained in Figure 17.

Figure 17: Damages of Sidi Beshher beach due to waves attacks during 2010 storm.

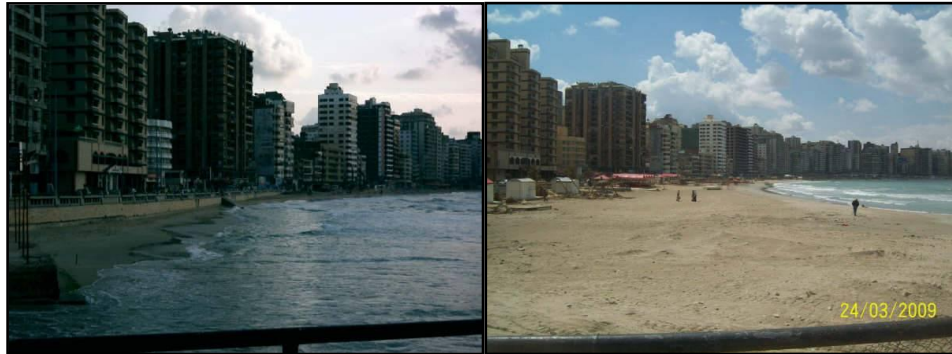
Two years after the construction of the submerged breakwater at zone 10, the beach width behind it varied from 50 to 150 meter compared to 0.0 to 20.0 meters before installation without any nourishment. Figure 18 present a comparison between the beach width after and before the construction of the submerged breakwater.

Figure 18: Comparison between the beach width after and before the construction of the submerged breakwater at Mandra beach (El-Sharnouby & Soliman, 2010)

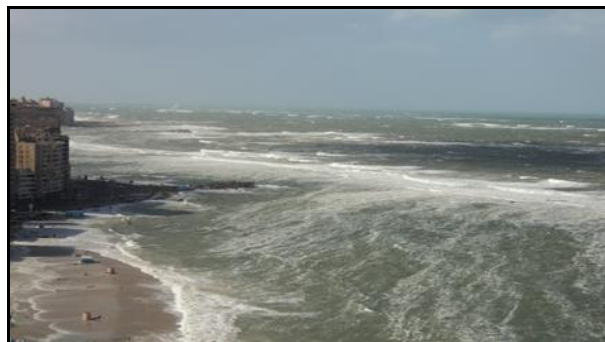
During this storm, the breakwater showed the same trend. Approaching high waves were broken over the submerged breakwater with transmission efficiency more than 75% as can be seen from Figure 19. The adequate water area behind the breakwater contributed well in dissipating the transmitted energy.

Figure 19: Waves breaking over the submerged breakwater at Mandara beach during the storm of winter 2010.

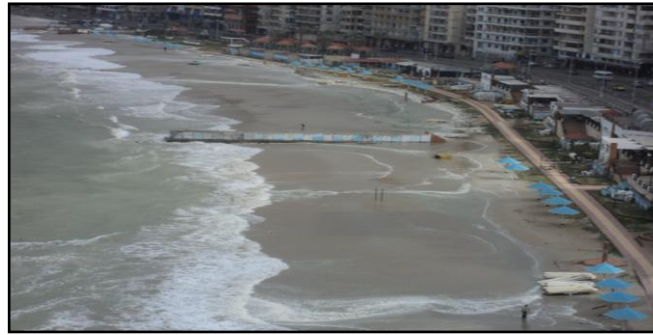
The wide sand beach took care of any left sweeping water. Figure 20 shows the good effect of submerged breakwater in the protection of Miami beach during the storm of winter 2010.

Figure 20: Effect of submerged breakwater in the protection of Miami beach during the storm of winter 2010.

The sea shore remained untouched in most locations along Miami-Montaza zone. Only few spots suffered gentle movement of water and sand to the street without any sort of destruction. After the storm, the breakwater itself was examined and no loss of his stone layers was recorded. The sand beach did not lose that much and regained its beach lines within weeks. The good performance of the submerged breakwater may be due to the followings:
